THE MOORES PROJECT

Conservation of The Moores Complex of Buildings

Booklet Prepared by the
Architecture & Heritage Section
City of Fremantle

April 1995

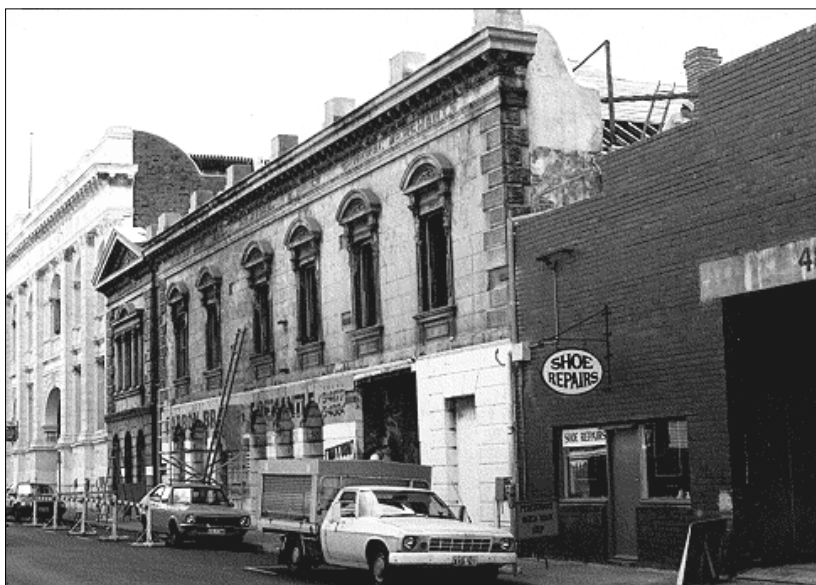
Figure 1: The Moores Building facade in 1986

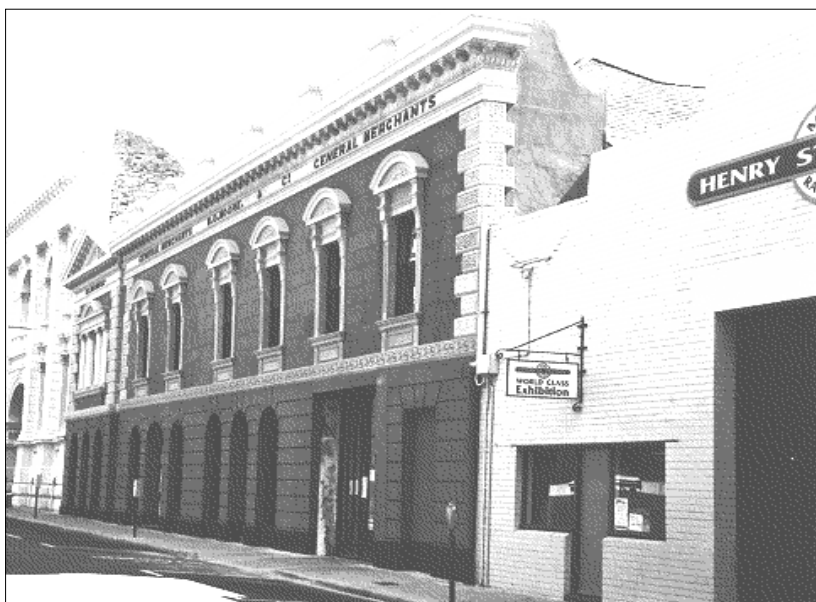
Figure 2: The restored Moores Building facade in 1994

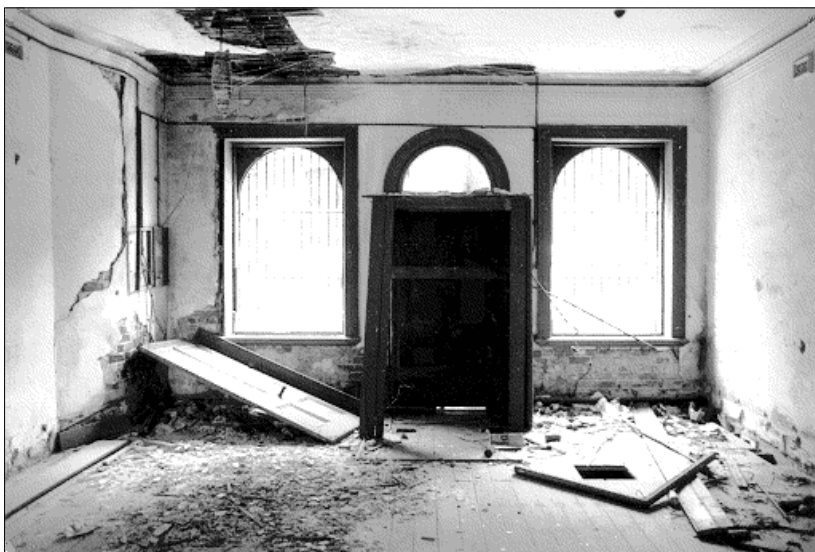
Figure 5: Debris in the front room of the former Residence in 1986

1. Site preparation - years of accumulated debris had to be removed, old stockpiles, rubbish, weeds, and rotting timbers which were affected by termites. The site was then made safe, and examples of building materials such as bricks, mortar, joinery and shingles were put to one side (fig 5).

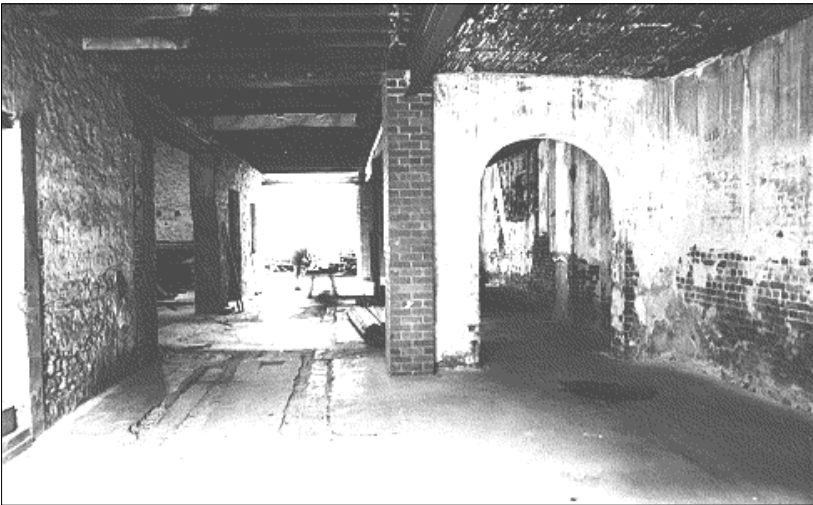
Figure 8: The Cartway prior to restoration

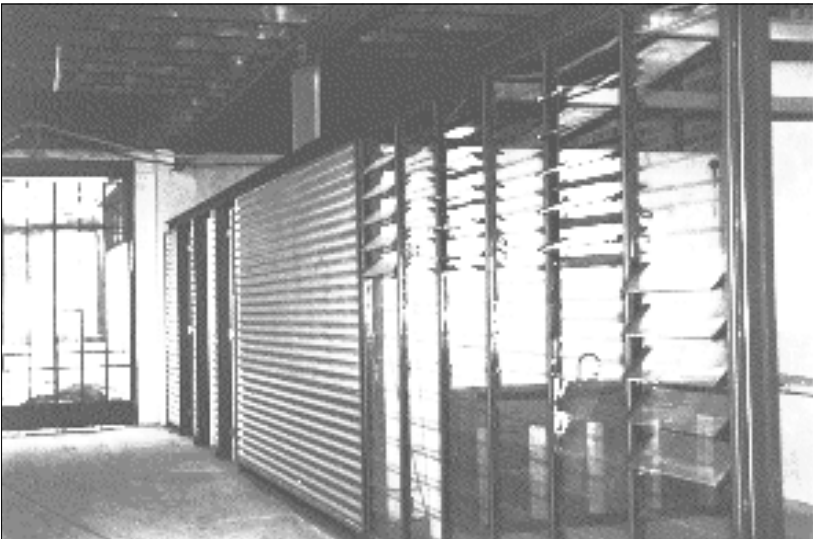
Figure 9: A new wall for the modern facilities constructed on the same plan as a former office wall in the Cartway.

Each design decision had to be taken on the merit of its particular case. For example the requirements of the client for toilet facilities inside the building demanded a subdivision of existing room(s). A judgement had to be made about where the toilets could be placed so that they would neither conceal nor obstruct the appreciation of the original spaces. In this instance the toilets were constructed in what used to be the former office space by reinstating the wall once dividing the cartway (figs 8 & 9). The reinstatement was carried out in modern materials because there was no physical evidence of the original wall. Therefore the original spatial arrangement has been

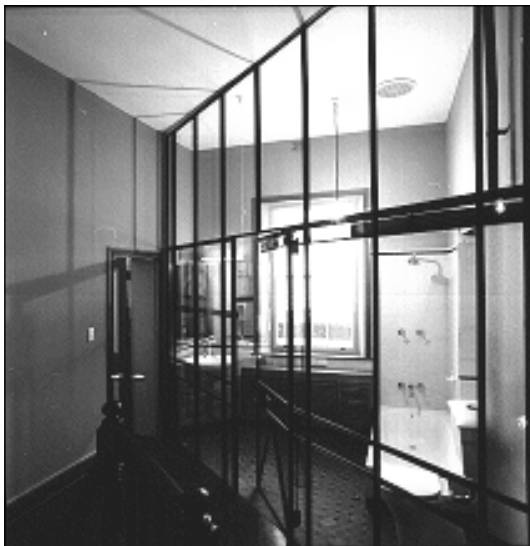
Figure 11: New bathroom facilities which allow the original space and character of the room to be appreciated

Functional requirements created many more opportunities for innovative design work. Another example was the adaptation of the former residence to modern standards including satisfying requirements for internal bathrooms and toilets. Originally these were housed in out-buildings. This requirement produced a real challenge because dividing any space by the small cubicles needed for these facilities could obscure or obstruct the original walls, decorative details or spaces. The solution was to create a glass wall in a steel frame with narrow slatted venetian blinds for privacy (figs 10 & 11). Thus the original space and character of that part of the building can still be appreciated, while creating a bold but sympathetic juxtaposition between modern fixtures and fittings and the character of the original hallway.

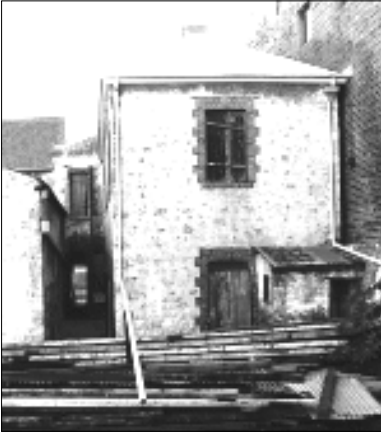
Figure 12: The rear to the former Residence in 1986

Another decision involved the addition to the townhouse of a conservatory so that extra living space could flow on from the kitchen. As this was a completely new structure it had to be sympathetic to the main building without mimicking its colonial style. The resulting design is totally modern yet it succeeds in contributing to the character of the whole space. Even though the architect took the old building as a generator of ideas he came up with a creative modern solution (figs 12 & 13).

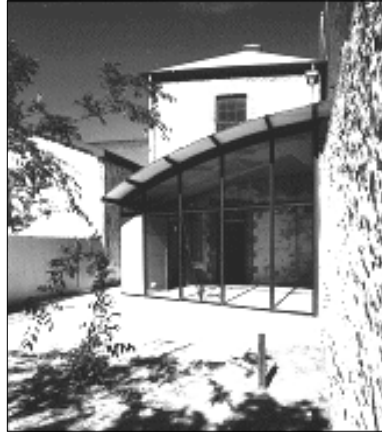
Figure 13: The addition of a modern and sympathetic conservatory provides required living space

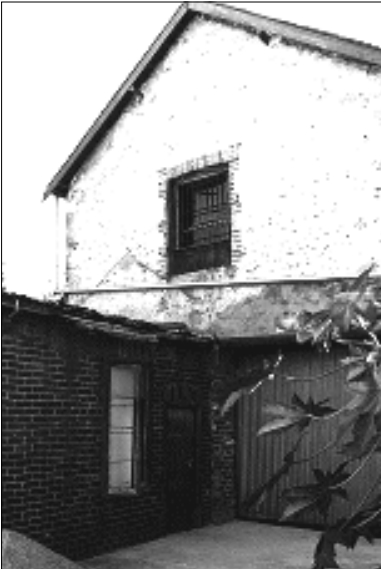
Figure 14: The flashing line of the former Stable roof was evident on the rear wall of the warehouse

needs of the client. In the absence of full physical evidence, decisions were made based on a thorough knowledge of what existed before. Clearly stated modern design solutions were used when insufficient information was available. This assists in the interpretation of the building's evolution and form, while avoiding confusion between the restored or reconstructed work and any new work. For example, the overall form of the former stables was reconstructed in accordance with the flashing line on the main building which indicated the height of the original building and the pitch of its former roof (figs 14 & 15). But the former stables' facade, for which no evidence could be found concerning its details, was expressed in a modern style and materials to indicate that it is a 1990's addition.

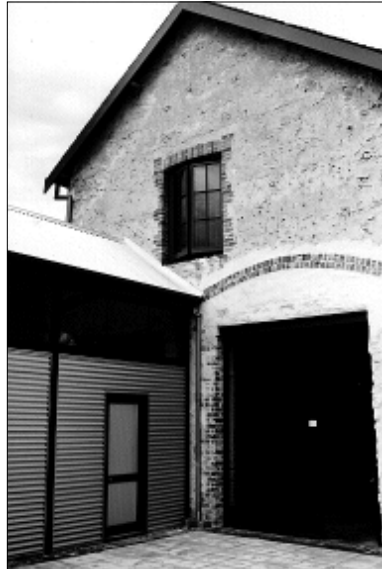
Figure 15: The form of the former Stables is interpreted by the new building. The elevation and details are clearly modern

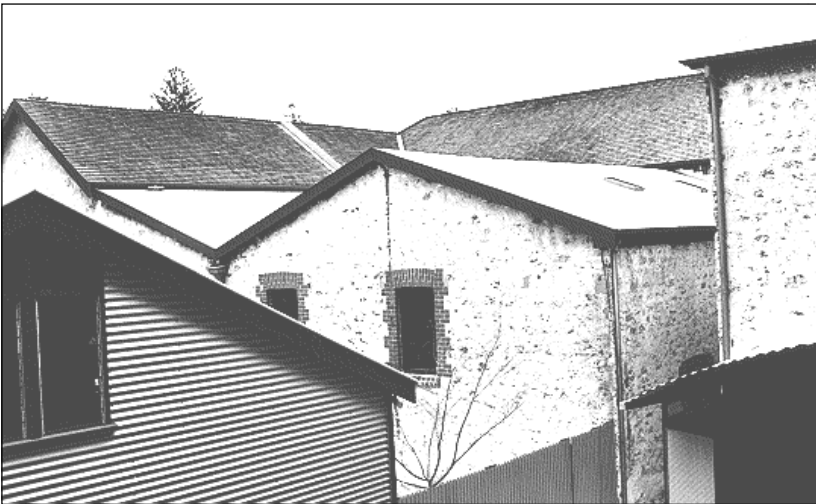
Figure 17: The former Warehouse roof was renovated using materials indicated by the evidence

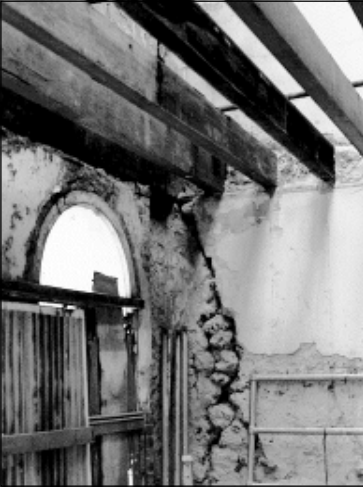
Figure 18: The front facade coming away from the side walls

An interesting aspect of the design process relates to the structural problems which normally present a real challenge in the restoration of old buildings. A knowledge of the building enabled the team to come up with the correct structural solutions to stop the deterioration of the building without compromising its cultural significance or the nature of its internal spaces. Thus the former shingled roof was reconstructed over the early buildings and the corrugated iron over the remaining structures as indicated by the evidence (figs 16 & 17). An example of a major structural problem was the facade. This was the last major significant addition to the complex and was in danger of becoming detached from the main building and falling into the street (figs 18 & 19). The facade was stabilised by implementing the modern solution of introducing post-tensioned metal ties which fixed the facade to concrete anchors within the cross walls (figs 20 & 21). The anchors would normally have been plastered over to make them invisible but in some justified instances they were

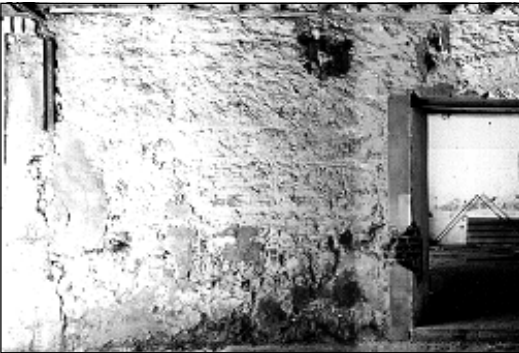
Figure 20: One of the walls which were used to anchor the facade

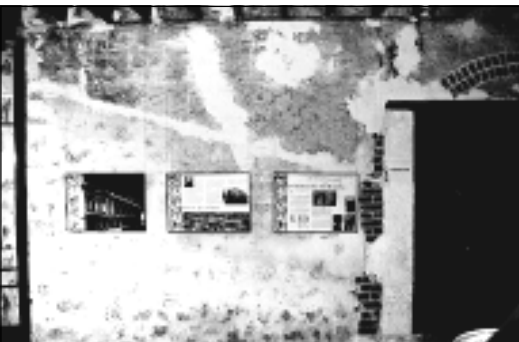
Figure 21: The position of metal ties in the wall and the concrete anchor against the door jam can clearly be seen. Also note the brick quoins and arch to the former doorway

exposed and used to reconstruct former openings in the walls.

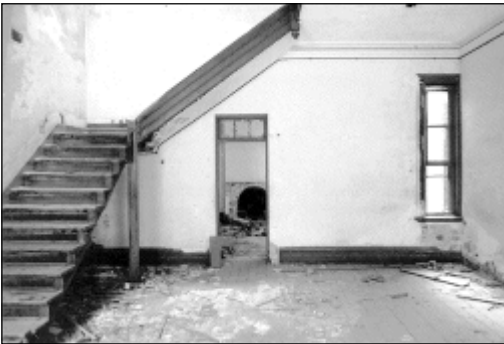
Figure 22: The front room of the former Residence in 1986

From a dilapidated, under-used building which was a constant drain on the Council purse, the building now provides a largely self sustaining investment with increasing capital value (figs 22 & 23). The overall average cost of restoration was \$720 per square metre in 1994. This was approximately half of the cost of constructing a new building for similar uses.

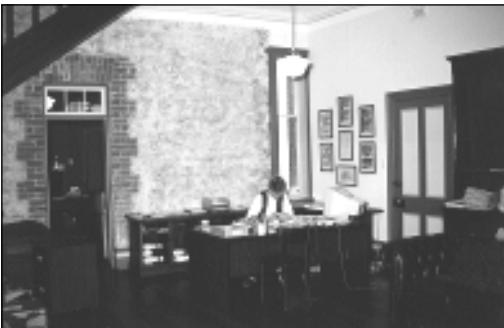
Figure 23: The same room after restoration used as an office
